15 year exposure test result in a general environment

Verify the anti-corrosion performance of ROVAL and Hot-Dip Galvanizing by an atmospheric exposure.

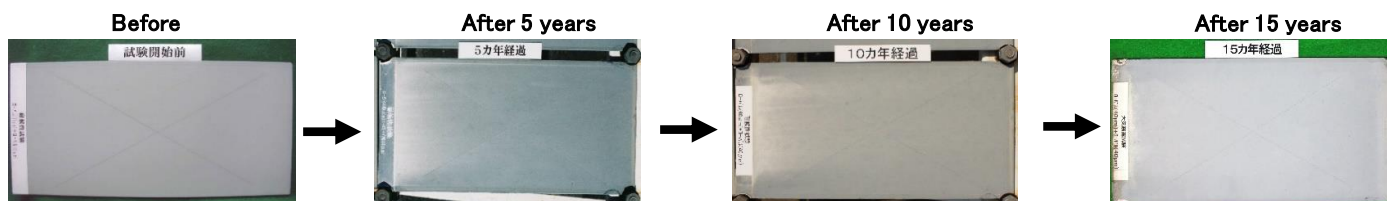
ROVAL (Film thickness: 80µm)

Color change of the film was seen but stayed without rust for 15 years.

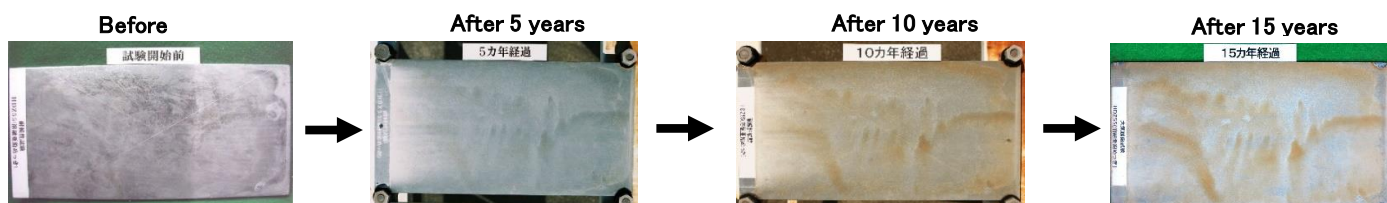
Hot-Dip Galvanizing (HDZ55)

Rust occurred on gray zone, which is probably due to corrosion of ferrous of zinc-ferrous alloy layer.

However, the rust was only on its surface and not heavy.
