15 year exposure test result in a general environment

Verify the anti-corrosion performance of ROVAL and Hot-Dip Galvanizing by an atmospheric exposure.

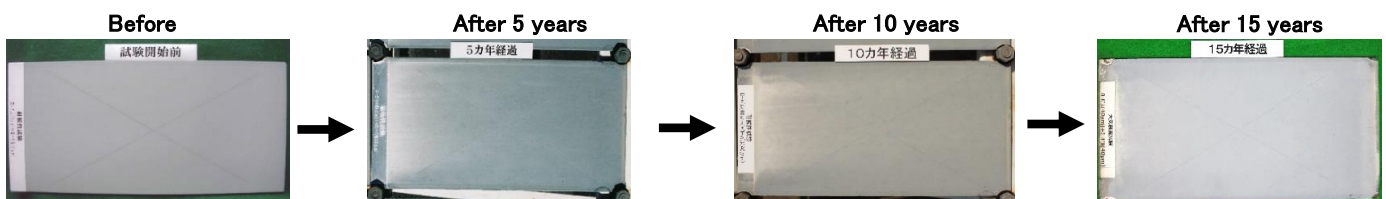
ROVAL (Film thickness: 80µm)

Color change of the film was seen but stayed without rust for 15 years.

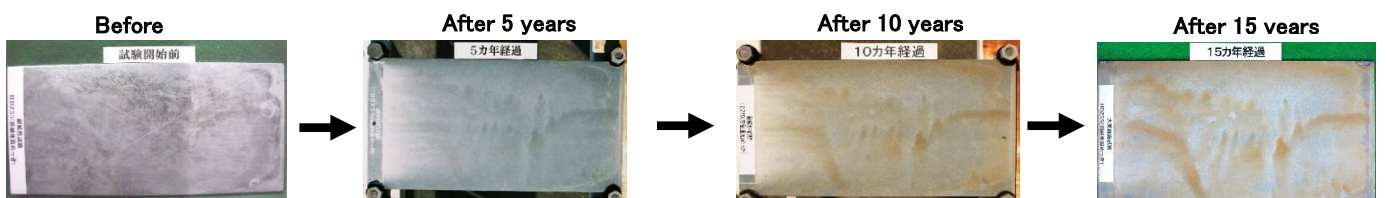
Hot-Dip Galvanizing (HDZ55)

Rust occurred on gray zone, which is probably due to corrosion of ferrous of zinc-ferrous alloy layer. However, the rust was only on its surface and not heavy.
