## 20 year exposure test result in a general environment

Verify the anti-corrosion performance of ROVAL and Hot-Dip Galvanizing by an atmospheric exposure.

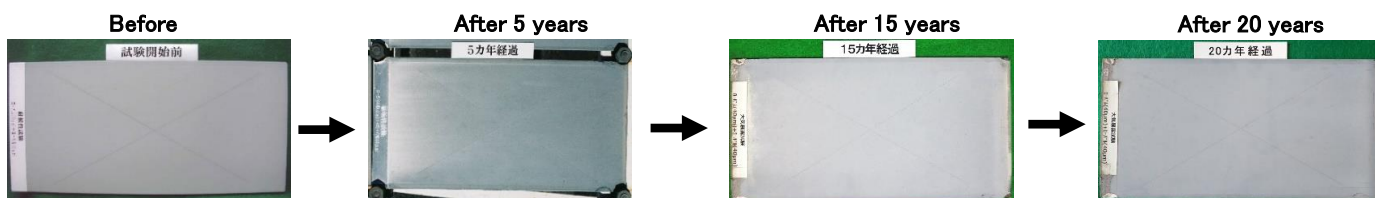
#### ROVAL (Film thickness: 80μm)

Color change of the film was seen but stayed without rust for 20 years.

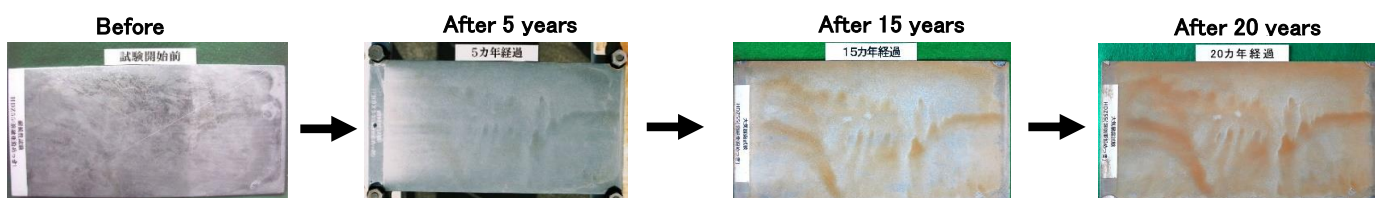
#### Hot-Dip Galvanizing (HDZ55)

Rust occurred on gray zone, which is probably due to corrosion of ferrous of zinc-ferrous alloy layer. However, the rust was only on its surface and not heavy.
