TEST REPORT

No. : SHMR260300472501
Date : Oct 23, 2026
Page: 1 of 12

Sample Name : ROVAL Cold Galvanizing Compound (120μm)

1. Test Item: Neutral Salt Spray Test

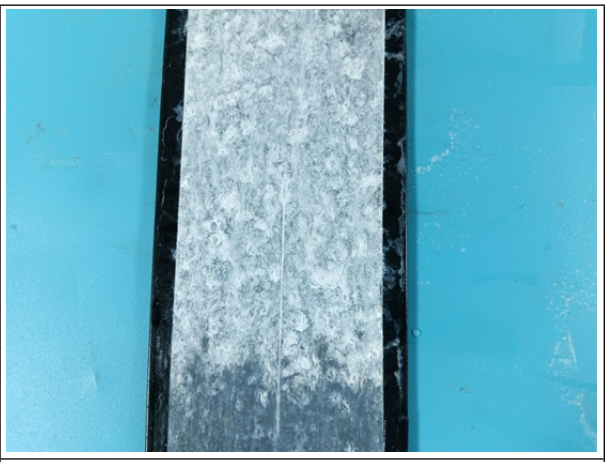
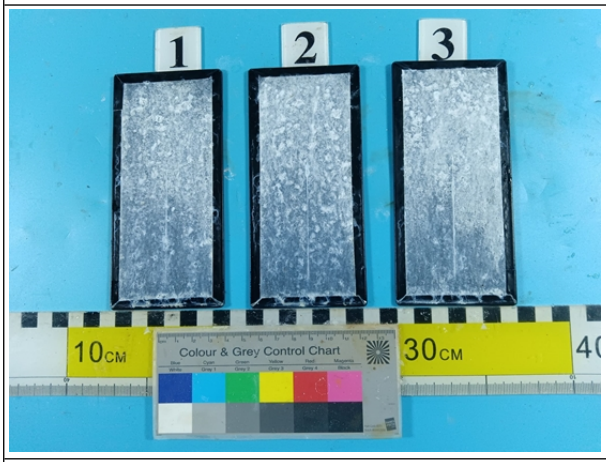
<table><tr><td colspan="2">
</td></tr><tr><td>After Test-Sample A-1008h</td><td>After Test-Sample A-Local part 1008h</td></tr></table>

Test Duration	Specimen	Appearance	Degree of Blistering (See note 1)	Degree of Rusting (See note 2)	Degree of Cracking (See note 3)	Degree of Flaking (See note 4)
1008h	1	Visible white rust.	0(S0)	R%0	0(S0)	0(S0)
	2	Visible white rust.	0(S0)	R%0	0(S0)	0(S0)
	3	Visible white rust.	0(S0)	R%0	0(S0)	0(S0)
2016h	1	Visible white rust.	0(S0)	R%0	0(S0)	0(S0)
	2	Visible white rust.	0(S0)	R%0	0(S0)	0(S0)
	3	Visible white rust.	0(S0)	R%0	0(S0)	0(S0)
3024h	1	Visible white rust.	0(S0)	R%0	0(S0)	0(S0)
	2	Visible white rust.	0(S0)	R%0	0(S0)	0(S0)
	3	Visible white rust.	0(S0)	R%0	0(S0)	0(S0)

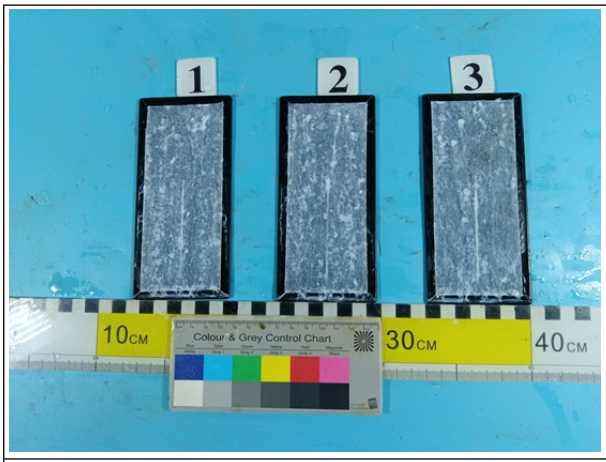
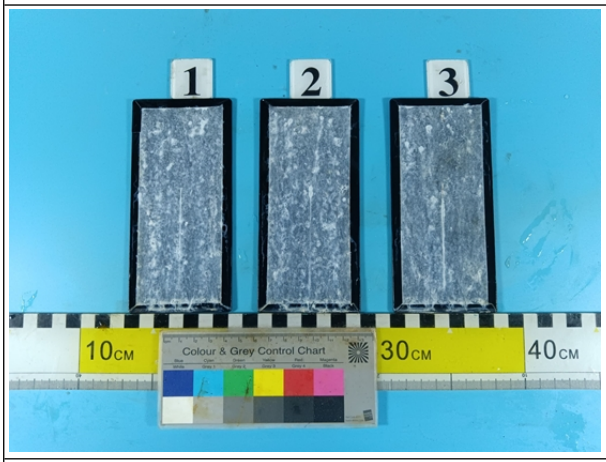
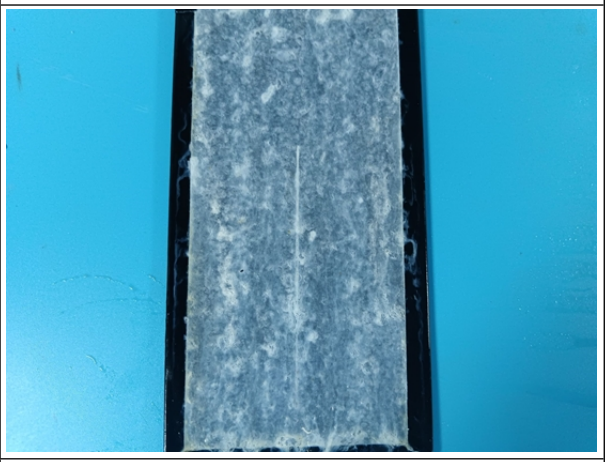
After Test-Sample A-2016h	After Test-Sample A-Local part 2016h

After Test-Sample A-3024h	After Test-Sample A-Local part 3024h

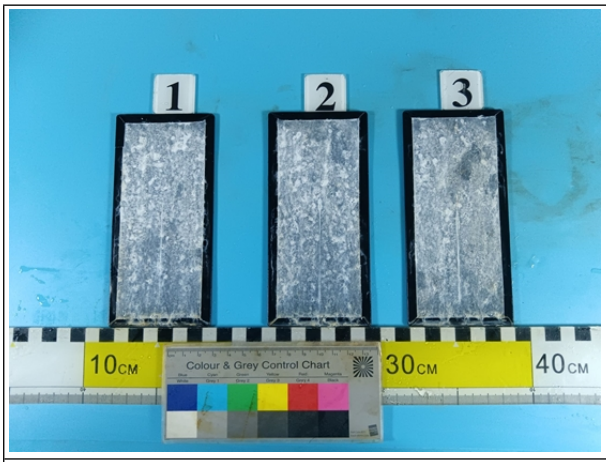
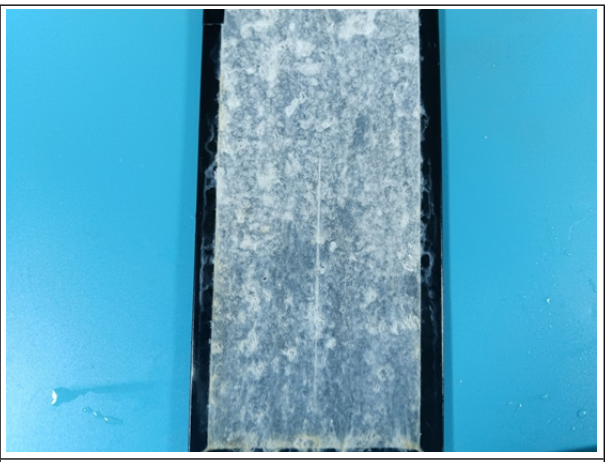
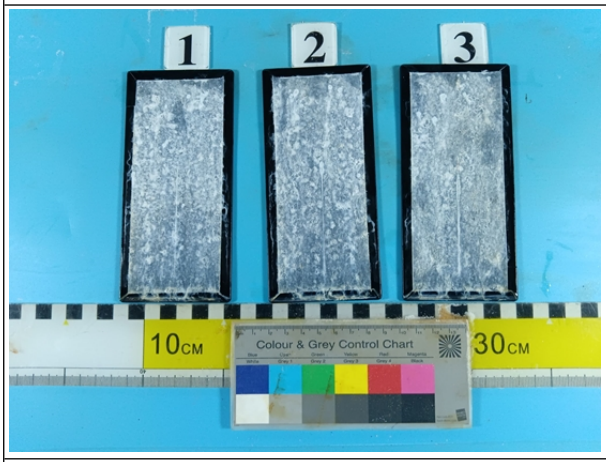
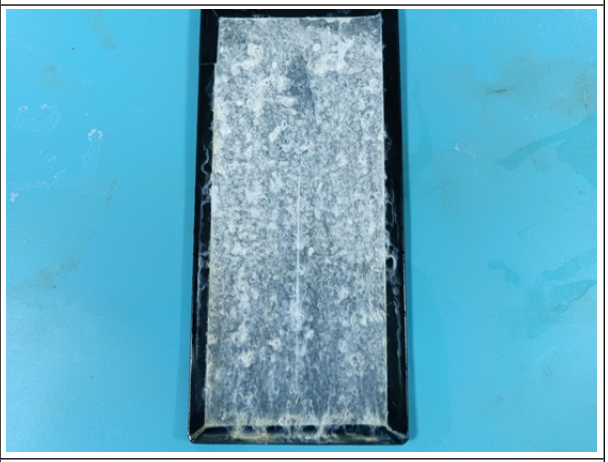
4032h	1	Visible white rust.	0(S0)	R%0	0(S0)	0(S0)
	2	Visible white rust.	0(S0)	R%0	0(S0)	0(S0)
	3	Visible white rust.	0(S0)	R%0	0(S0)	0(S0)
4200h	1	Visible white rust.	0(S0)	R%0	0(S0)	0(S0)
	2	Visible white rust.	0(S0)	R%0	0(S0)	0(S0)
	3	Visible white rust.	0(S0)	R%0	0(S0)	0(S0)
4368h	1	Visible white rust.	0(S0)	R%0	0(S0)	0(S0)
	2	Visible white rust.	0(S0)	R%0	0(S0)	0(S0)
	3	Visible white rust.	0(S0)	R%0	0(S0)	0(S0)
4536h	1	Visible white rust.	0(S0)	R%0	0(S0)	0(S0)
	2	Visible white rust.	0(S0)	R%0	0(S0)	0(S0)
	3	Visible white rust.	0(S0)	R%0	0(S0)	0(S0)
4704h	1	Visible white rust.	0(S0)	R%0	0(S0)	0(S0)
	2	Visible white rust.	0(S0)	R%0	0(S0)	0(S0)
	3	Visible white rust.	0(S0)	R%0	0(S0)	0(S0)

After Test-Sample A-4032h	After Test-Sample A-Local part 4032h

After Test-Sample A-4200h	After Test-Sample A-Local part 4200h

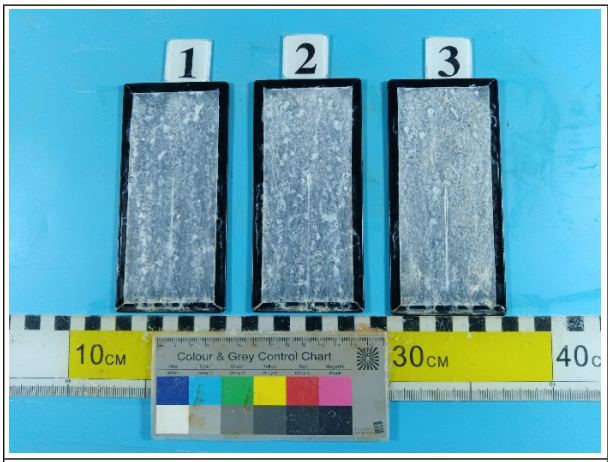
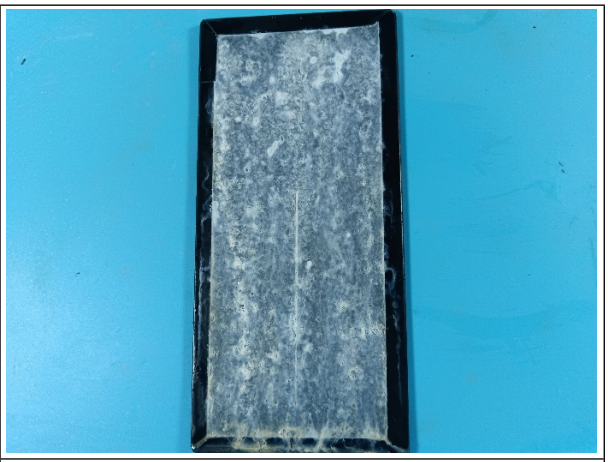
After Test-Sample A-4368h	After Test-Sample A-Local part 4368h

After Test-Sample A-4536h	After Test-Sample A-Local part 4536h
